1987
PARK EVALUATION
&
SITE SUMMARIES

MATTAPAN

EVALUATION OF
CITY OF BOSTON
PARK AND RECREATION LAND

THE HALVORSON COMPANY, INC.
LANDSCAPE ARCHITECTS AND
SITE PLANNING CONSULTANTS
161 MASSACHUSETTS AVENUE
BOSTON, MASSACHUSETTS 02115

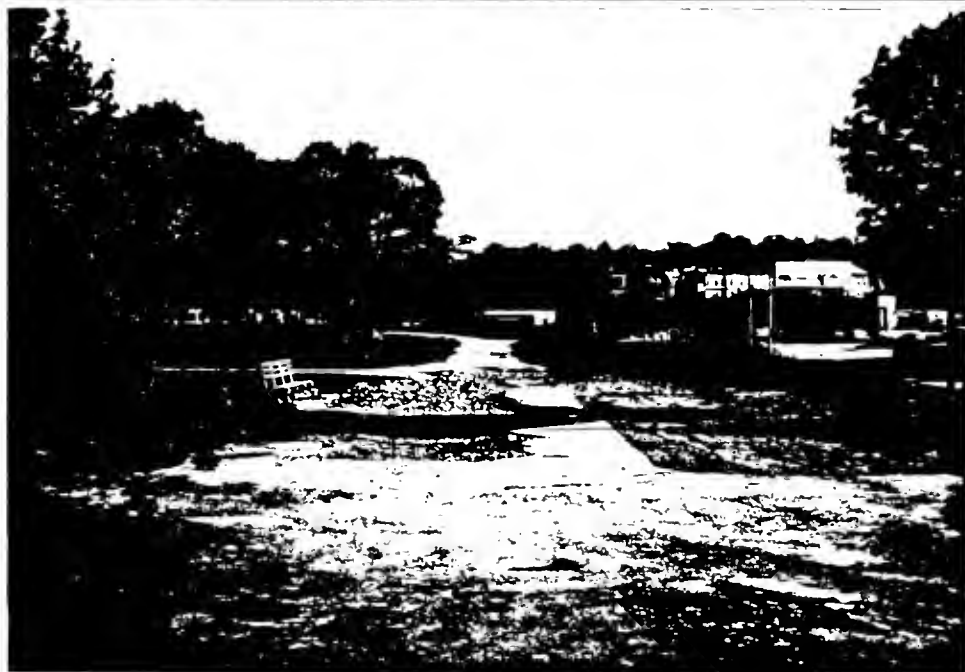
**Site Photograph 3**

Area of pavement
in poor condition,
worn grass.

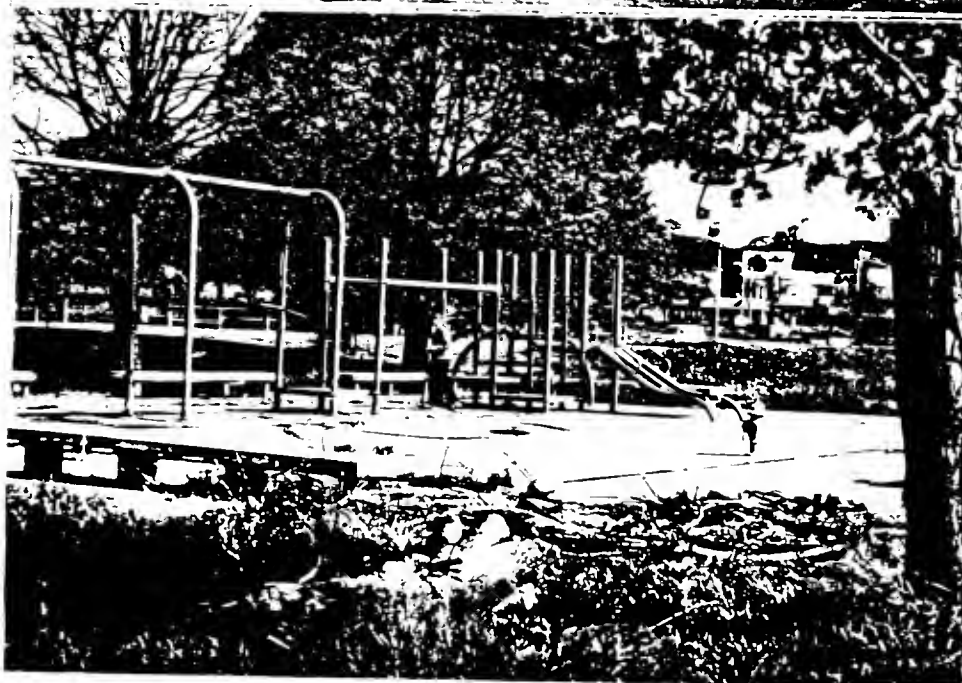
Site Photograph 18

Playground - Debris from dead tree needs removal. Rubber safety surface at base of structure easily removed. No slats left on swings.

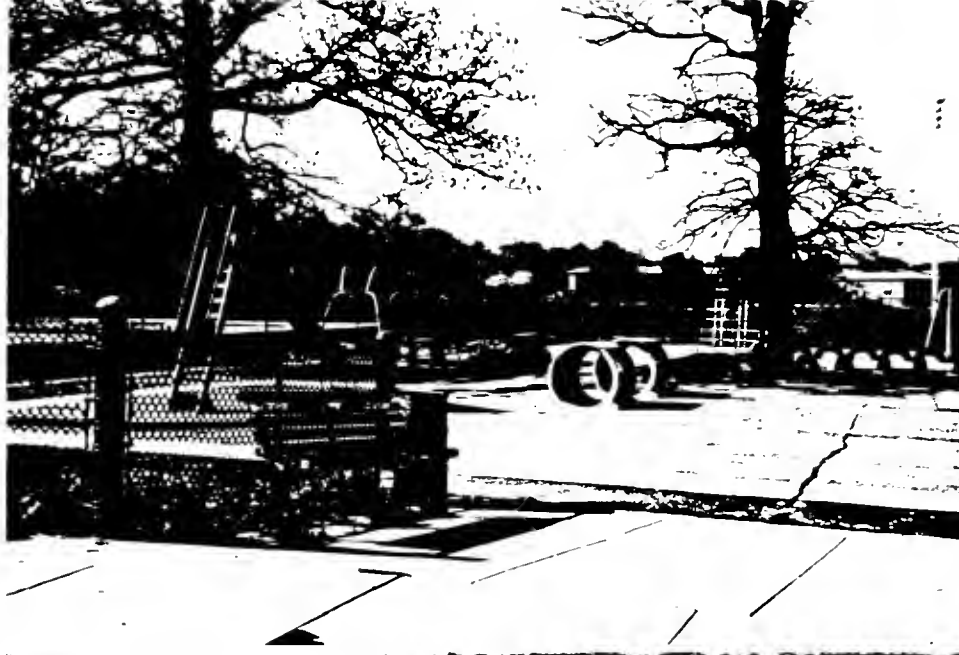
Site Photograph 13

Playground. Mature trees have been encased in pavement.

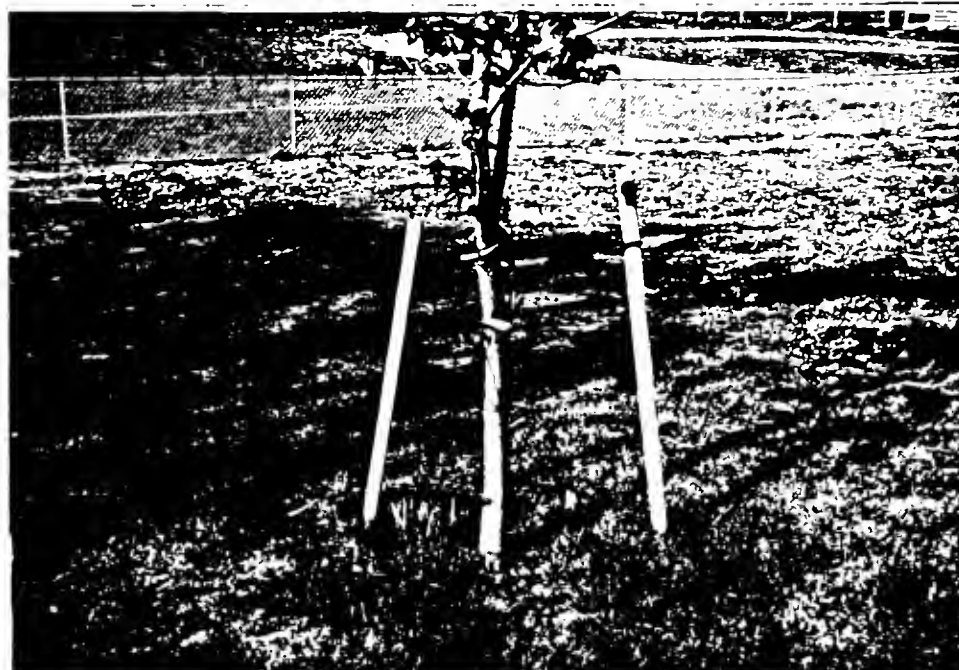
Site Photograph 15

Recent tree plantings. Guy wires and poles should be removed.

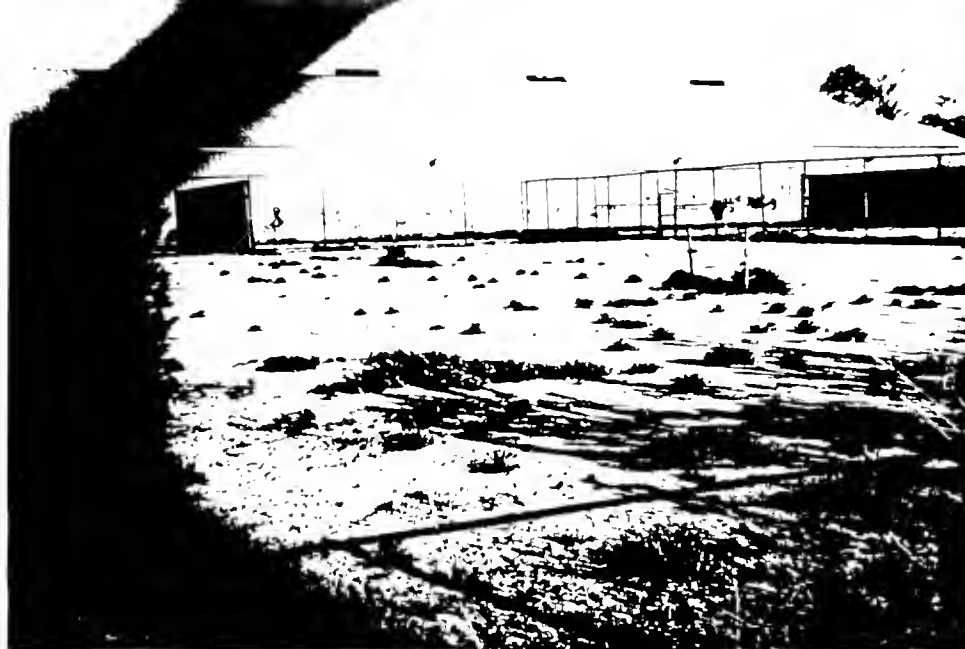
Site Photograph 7

Clay surface tennis courts - unusable.

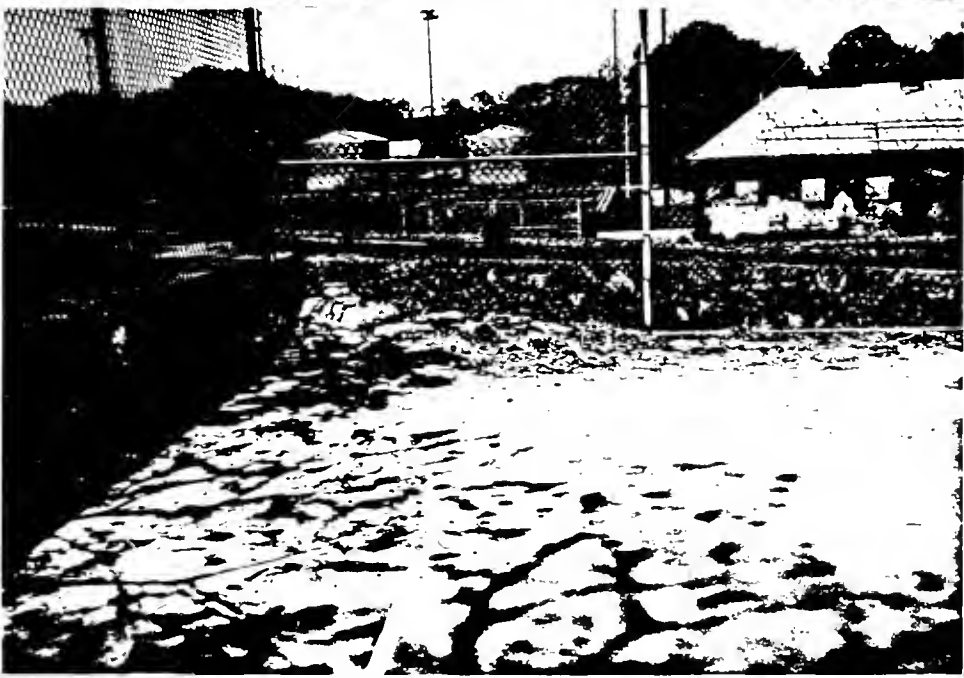
Site Photograph 2

Trash build-up in corner of basketball courts. Fence installed at base of wall results in leaves and debris trapped between them.

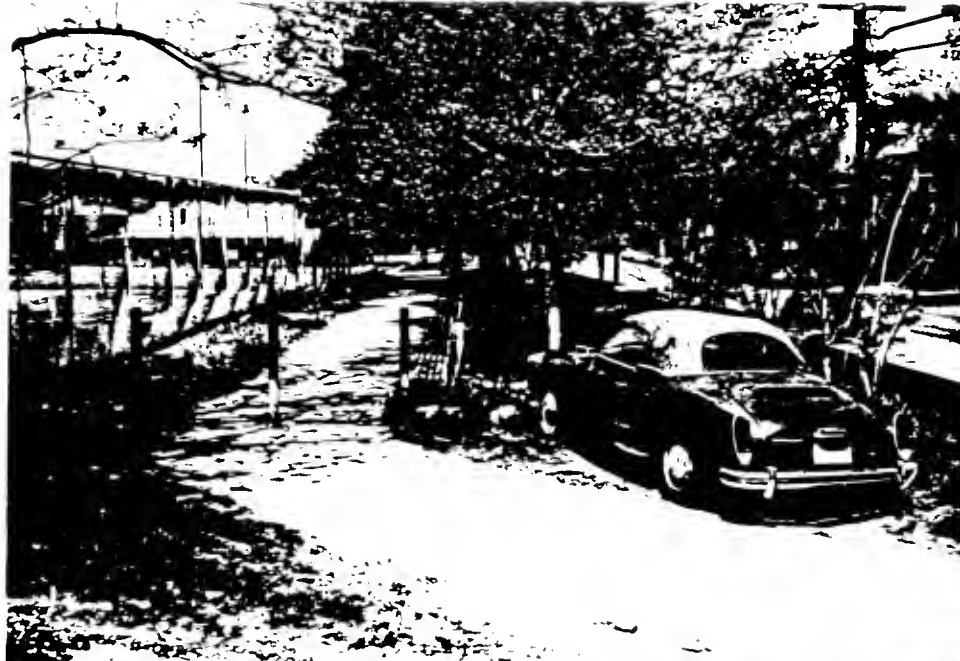
Site Photograph 4

Walkway along edge of park. Well-built wall but blocks visibility into park. Trees growing well in generous plant bed. Car inappropriately parked.

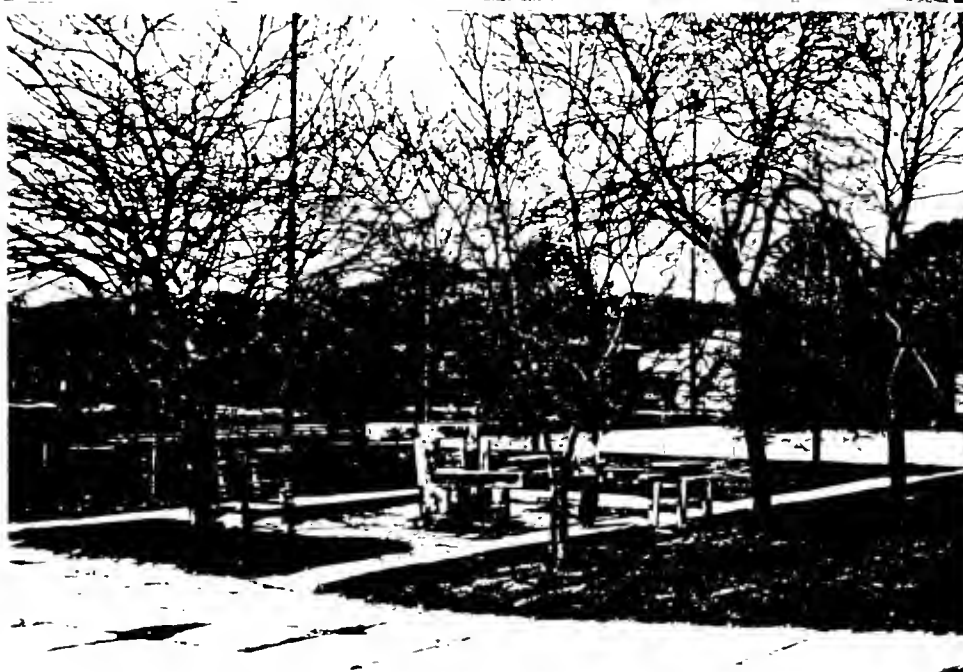
Site Photograph 6

Timber play structure - in poor condition. Shade trees good.

Equipment in the play area is inadequate and if there is a need for a playground in the neighborhood more equipment should be added.

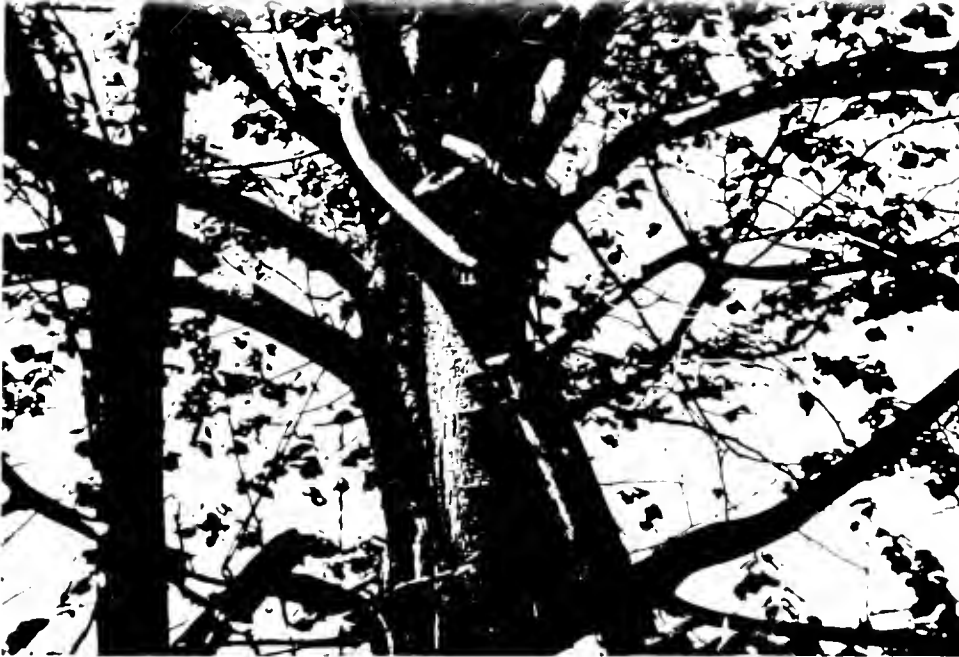
Site Photograph 7

Guy wires and stakes
have been on trees
8 years and should
be removed immediately.

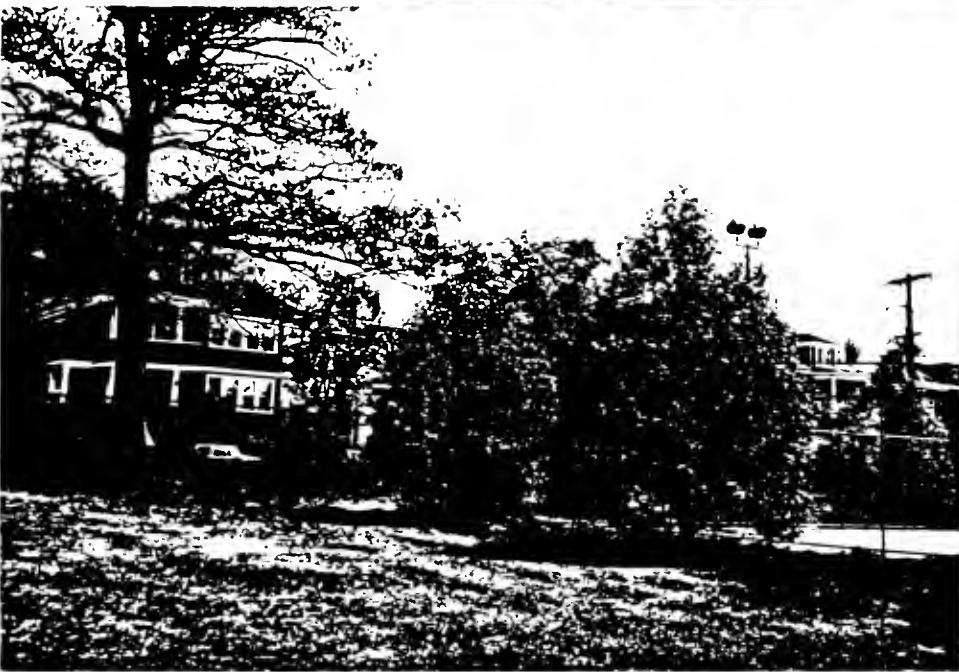
Site Photograph 8

Poor grass mowing -
small mower not used
to get into corners.

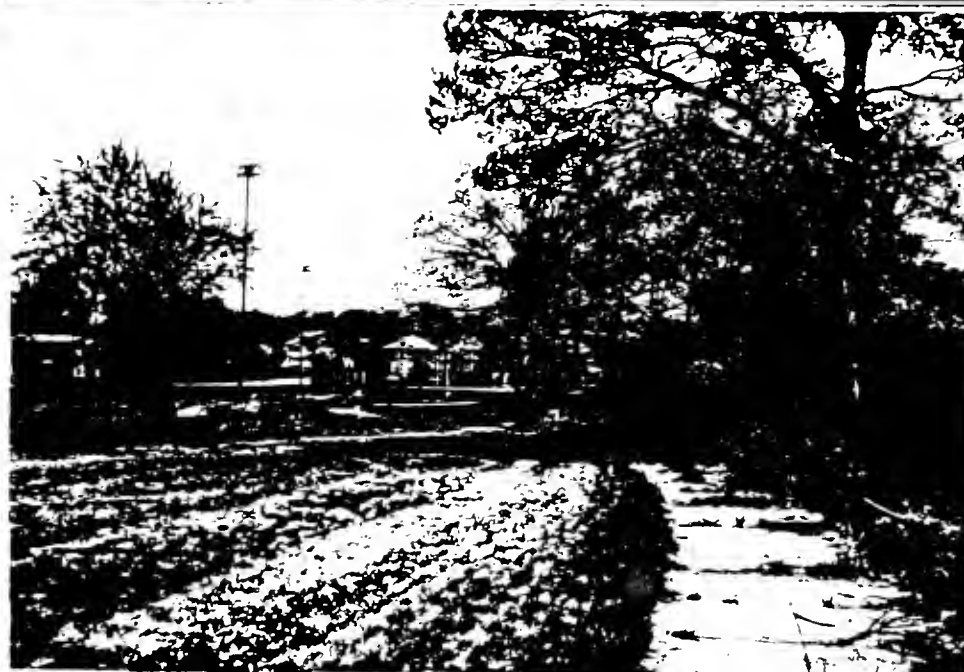
Site Photograph 12

Well laid-out walkway - in need of weeding.

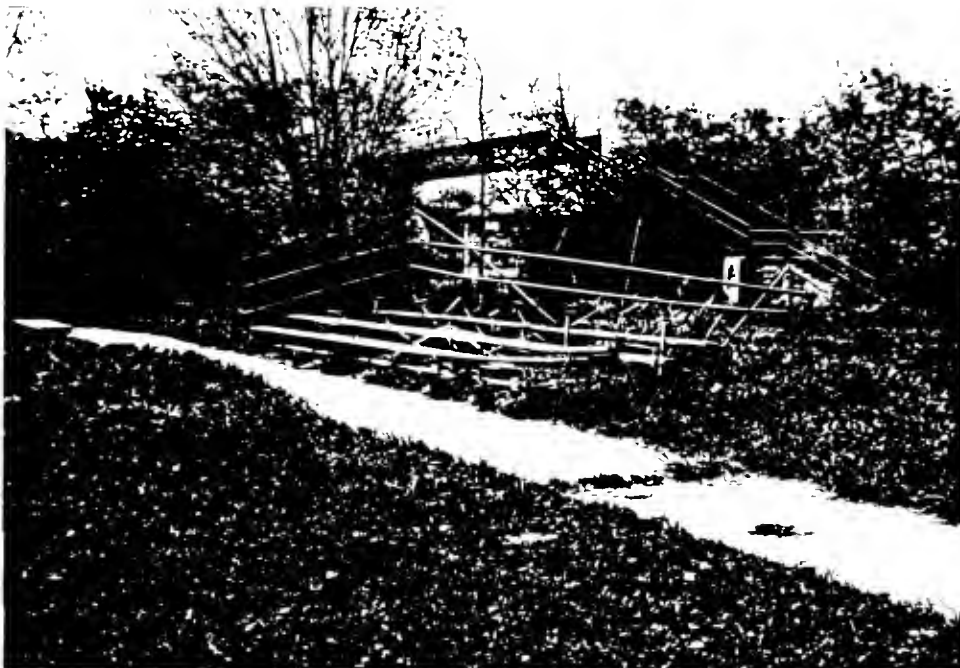
Site Photograph 1

Bleachers - unusable
due to vandalism.
Pedestrian railroad
bridge should be
attended to -
a safety hazard due to
deterioration.

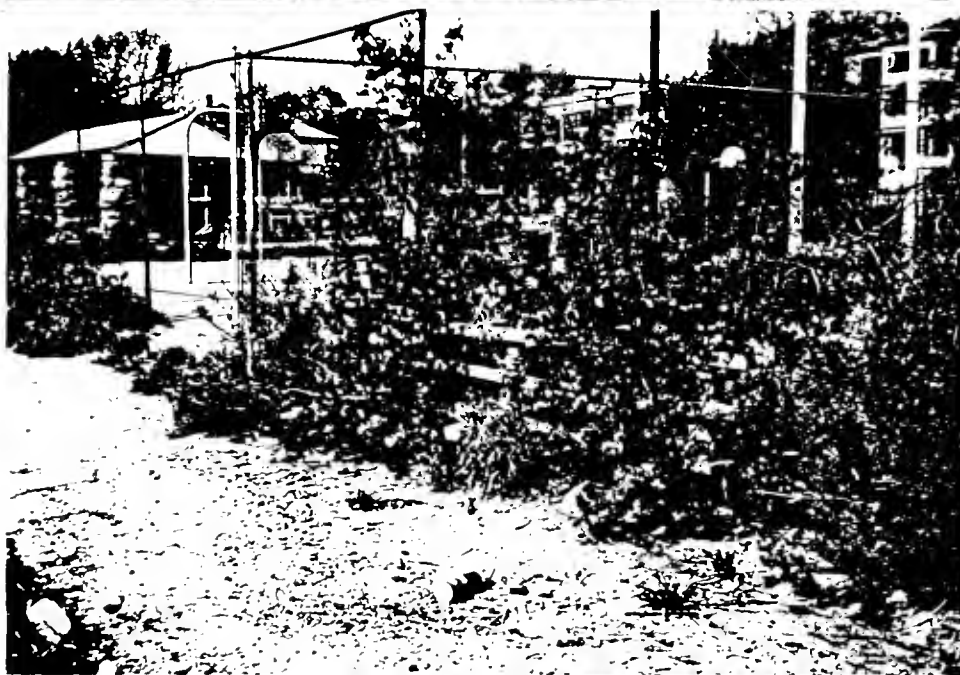
Site Photograph 2

Weed tree growth along
fenceline has
demolished bench.
Sidewalk surface poor.

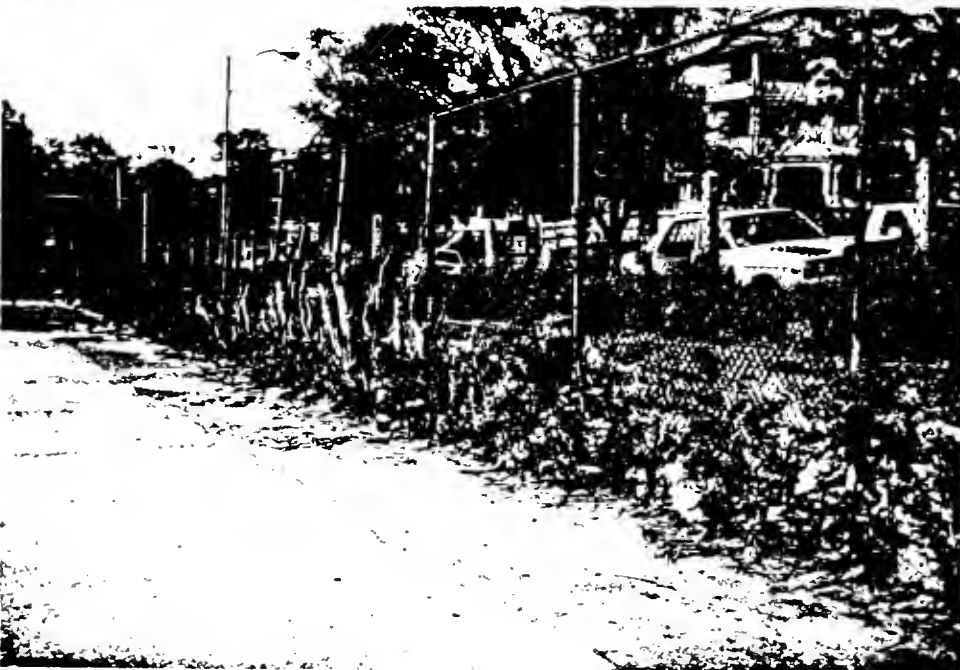
Site Photograph 3

Location of fence at
base of retaining
wall creates a
condition that is
very difficult to keep
weed free.

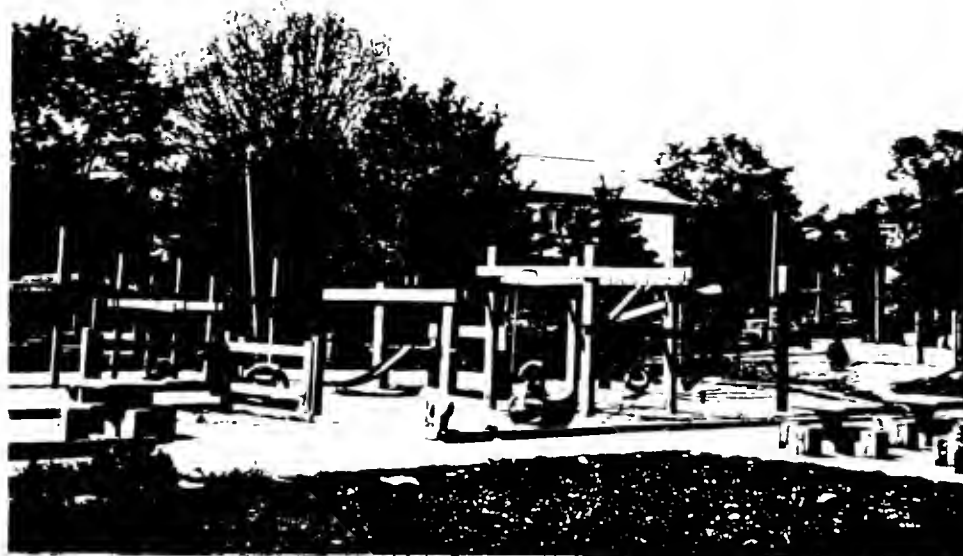
Site Photograph 10

Playground - Concrete play animals and timber climbing structures. Note fence down at corner at right, and grass worn by foot traffic.

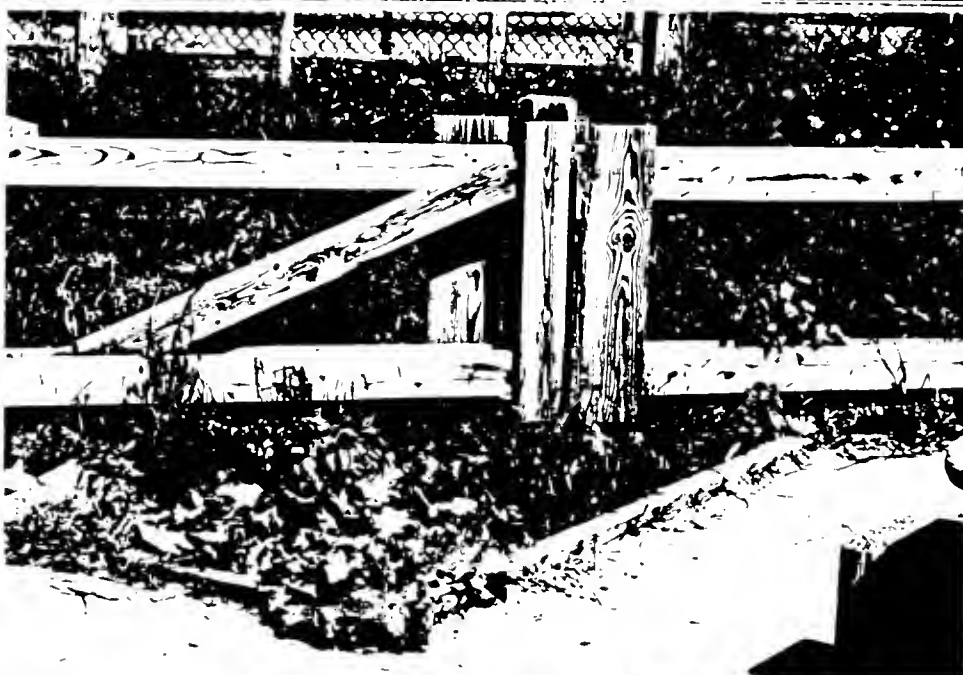
Site Photograph 11

Wood fence - picket removed and nail points protruding.

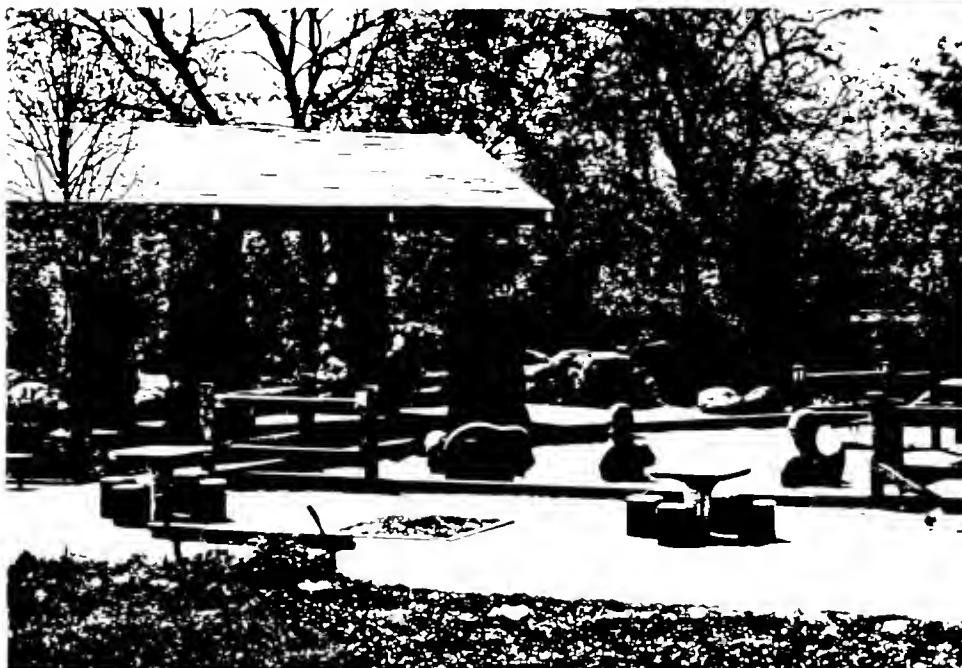
Site Photograph 12

Playground - note broken concrete animals, benches and graffiti. Park shelter and ruins of old house behind.

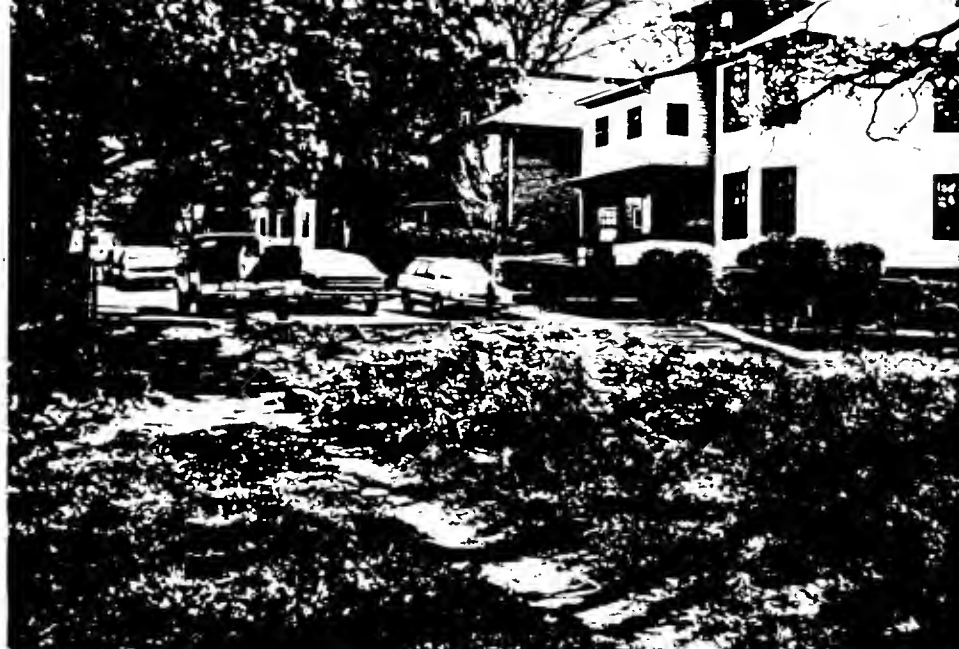
Site Photograph 7

Access from end street well used, but stairways badly deteriorated

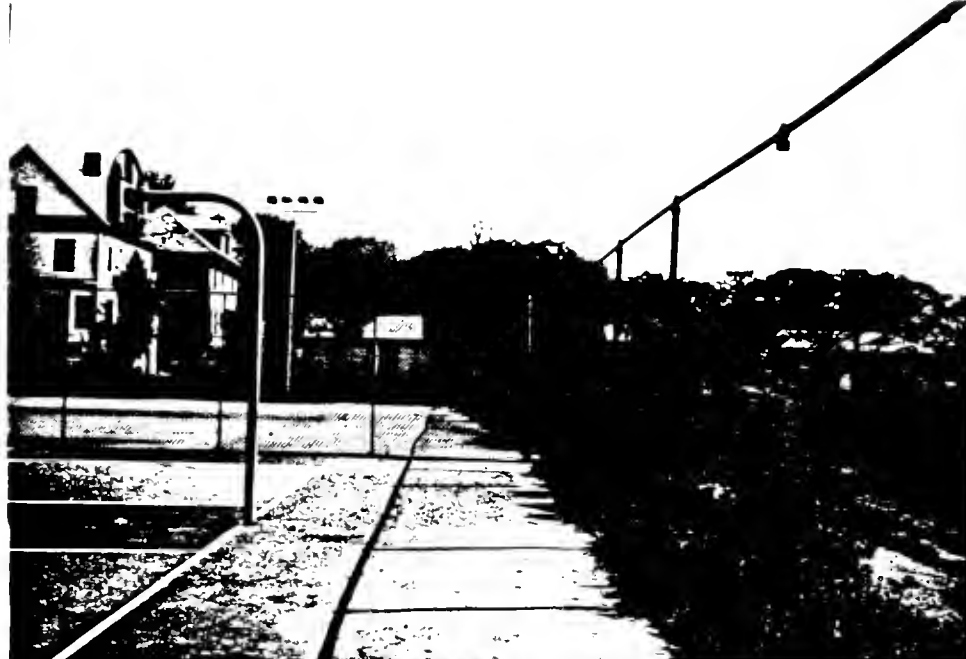
Site Photograph 4

Fencing removed. Weed growth along edge unsightly.

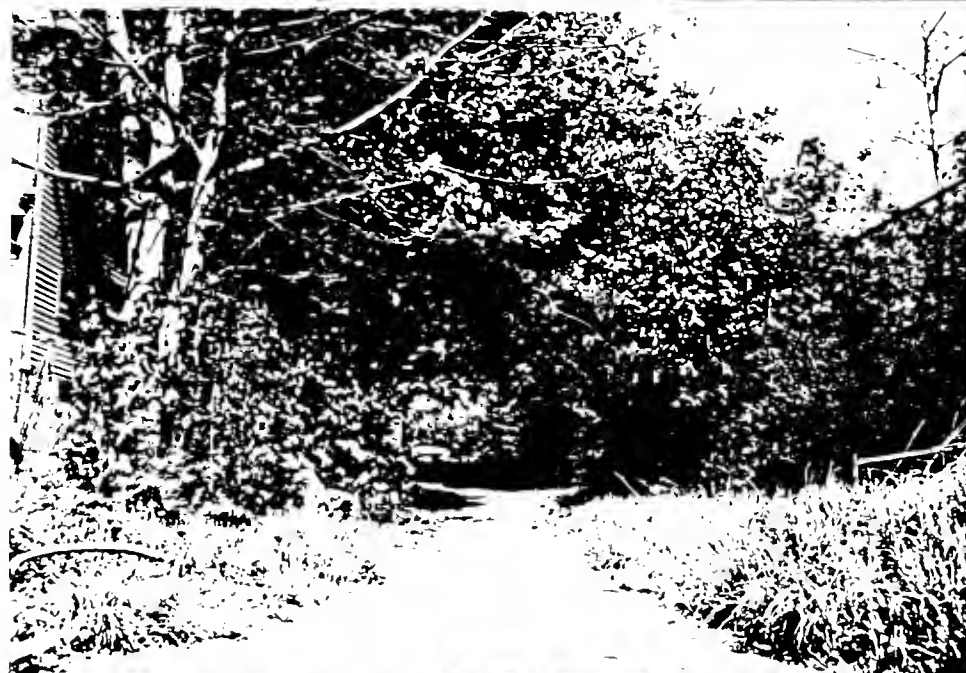
Site Photograph 5

Unkempt access from Norfolk Street. Overgrown planting gives walkway a feeling of lack of safety. Abandoned tennis court at right.

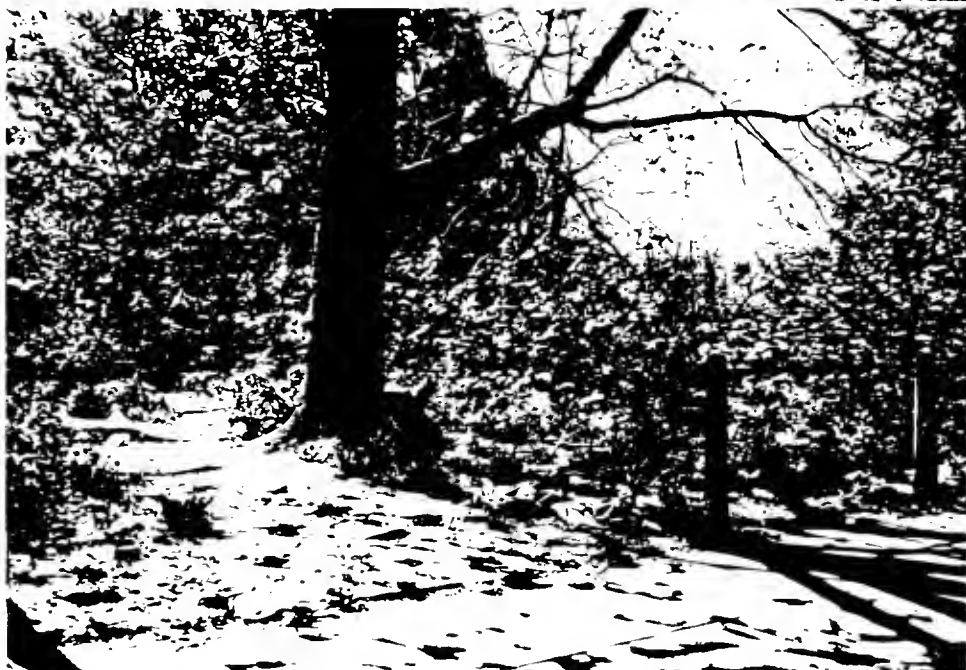
Site Photograph 6

Entrance to park from Norfolk Street area unmaintained. Dumping of trash and building materials.

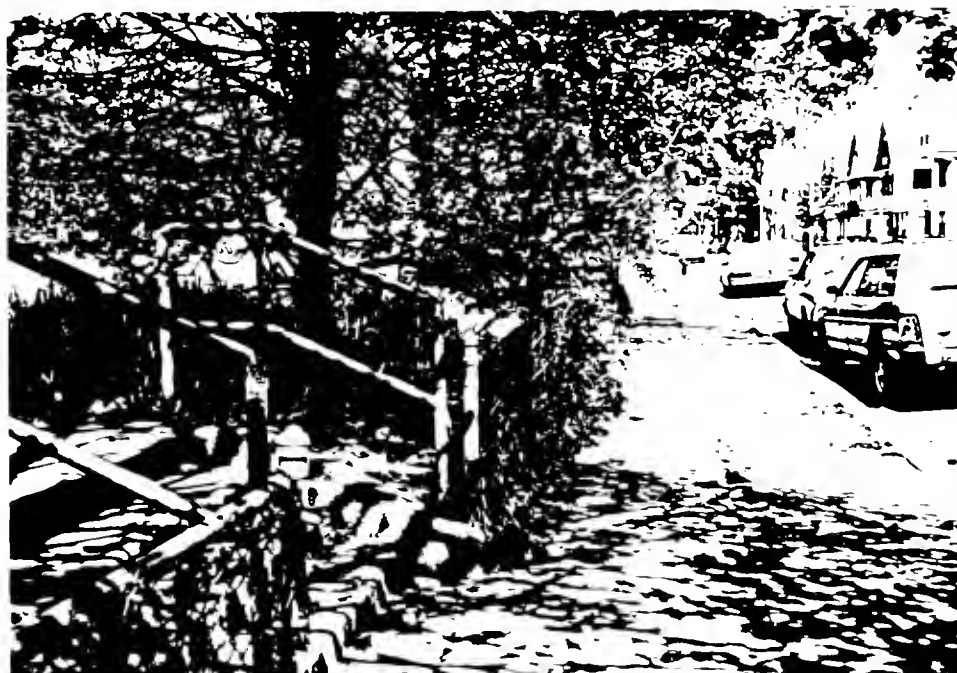
Site Photograph 3

Trash build-up and weed growth along fence line on Thetford Avenue.

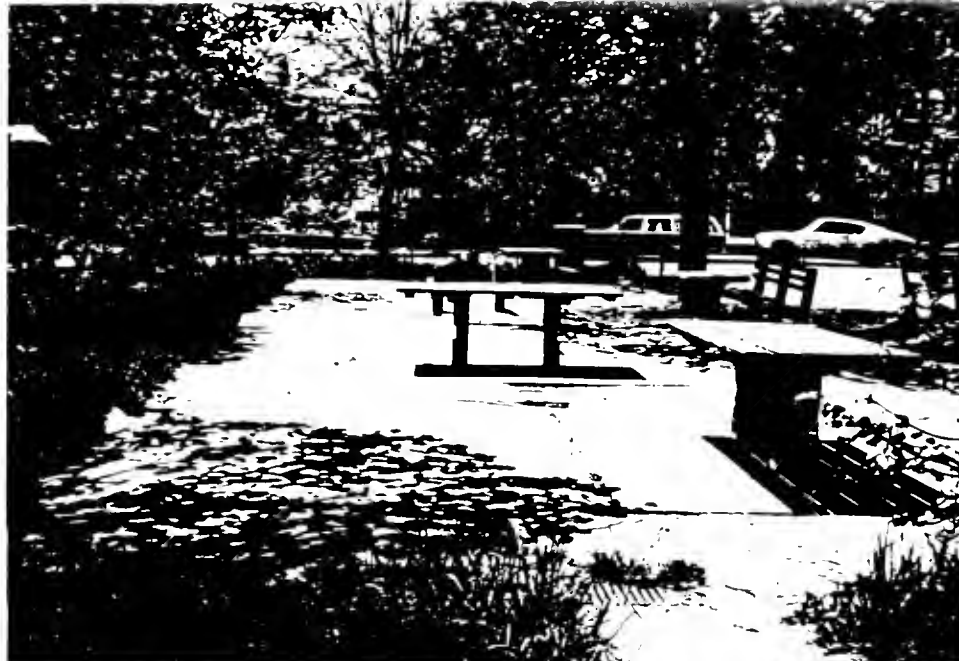
Site Photograph 4

Picnic area - broken tables and overgrown planting strip make space unattractive.

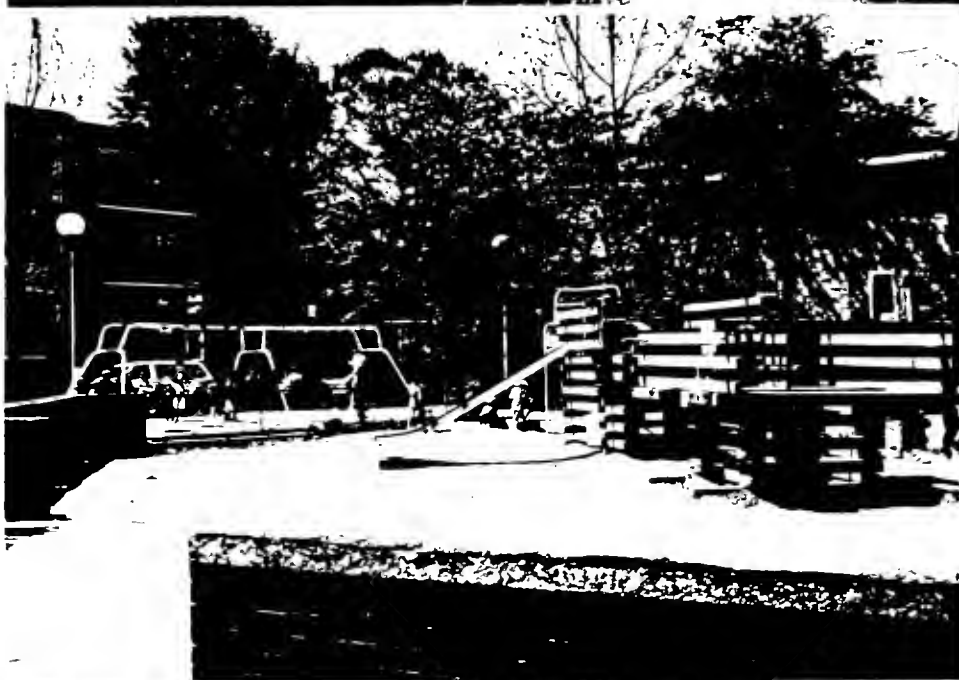
Site Photograph 5

Timber play structures and swings. Sand level too low.

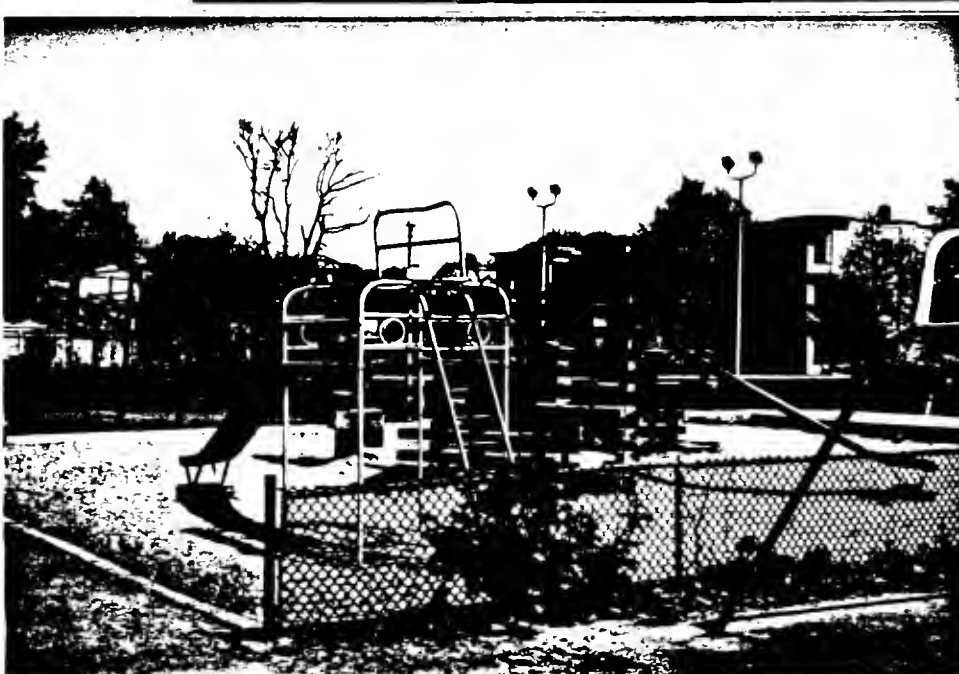
Site Photograph 6

Playground safety railing at top left of slide missing. Concrete footings exposed - both safety problems.

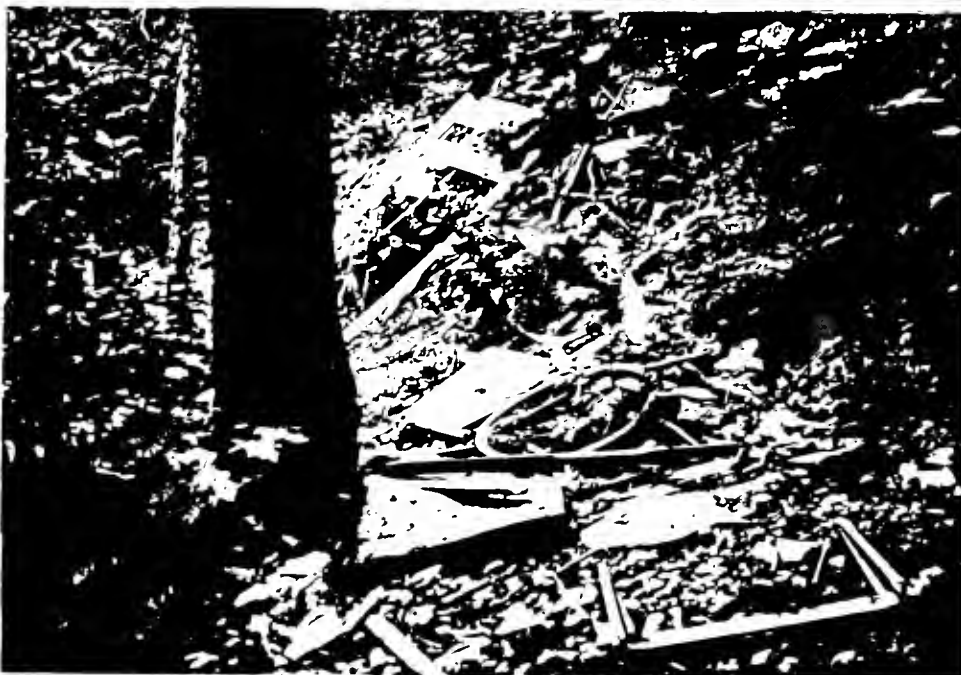
**Site Photograph 2**

Dumped material
covers entire site.

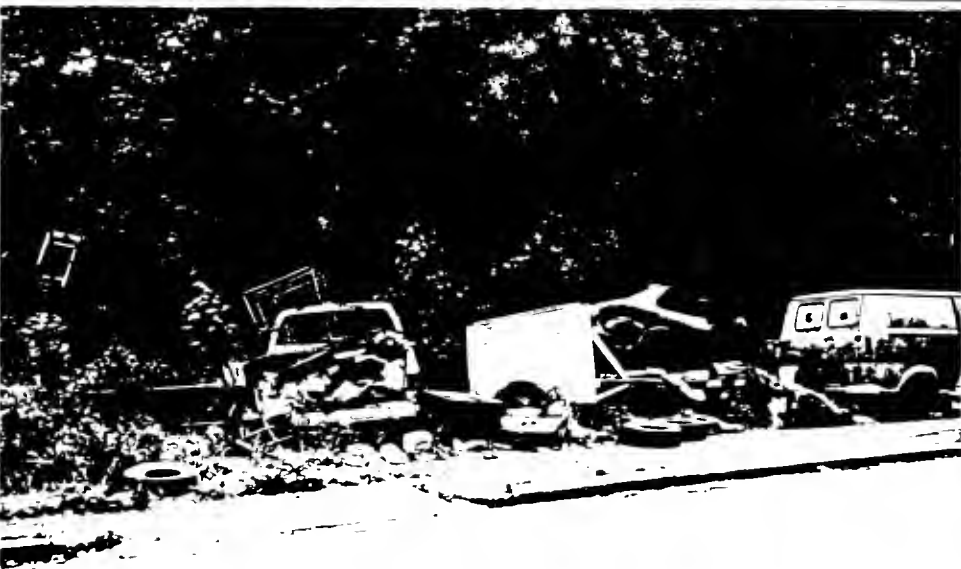
**Site Photograph 3**

Abandoned cars and
debris dumped on site.

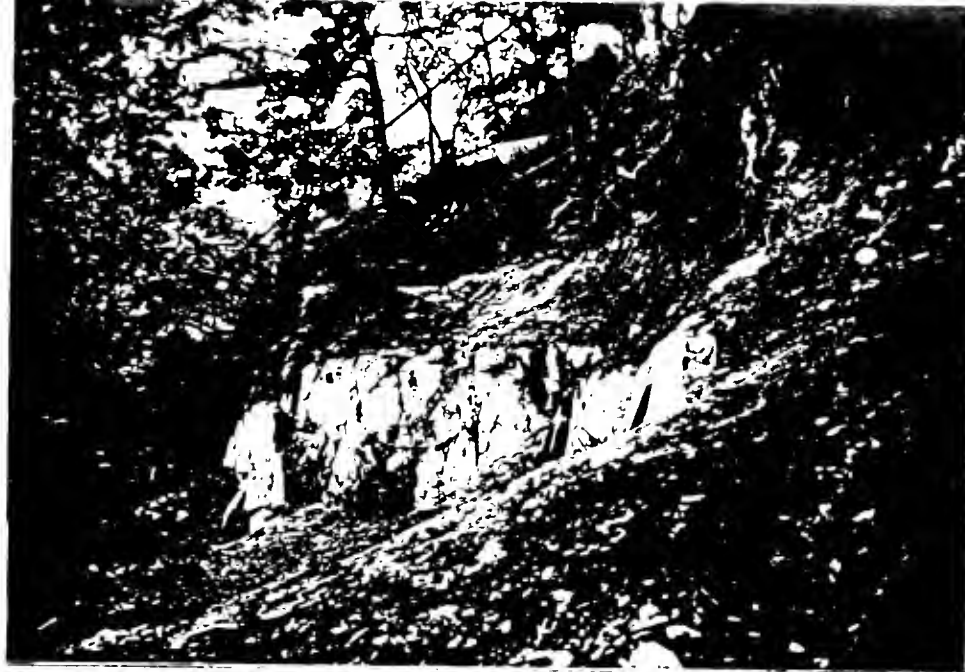
Site Photograph 4

Severe erosion,
presumably from play,
on slopes.

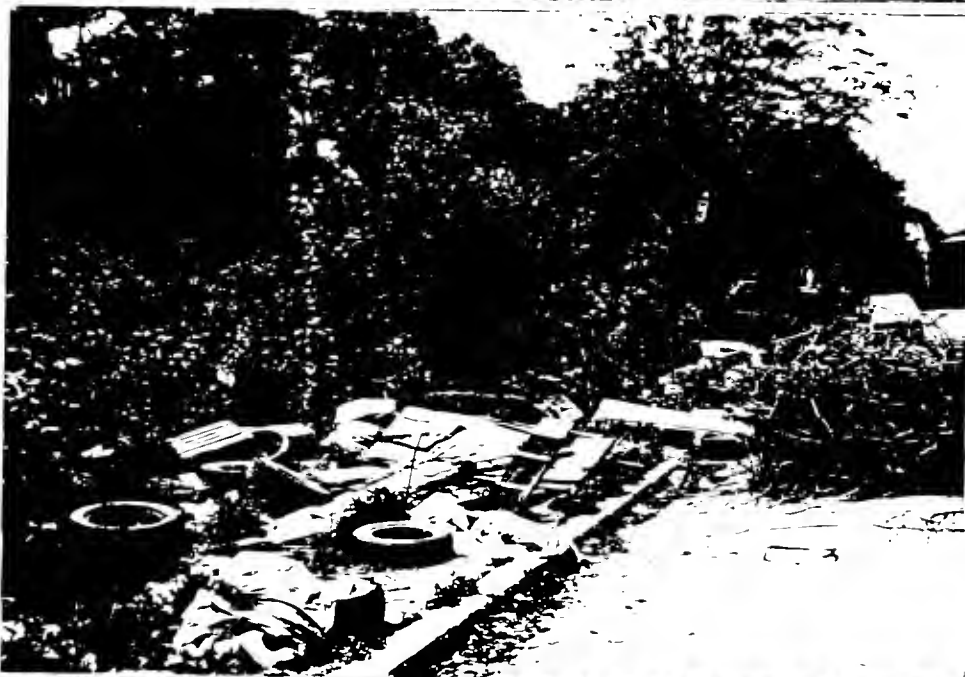
Site Photograph 5

Adjacent vacant site
used for dumping.
